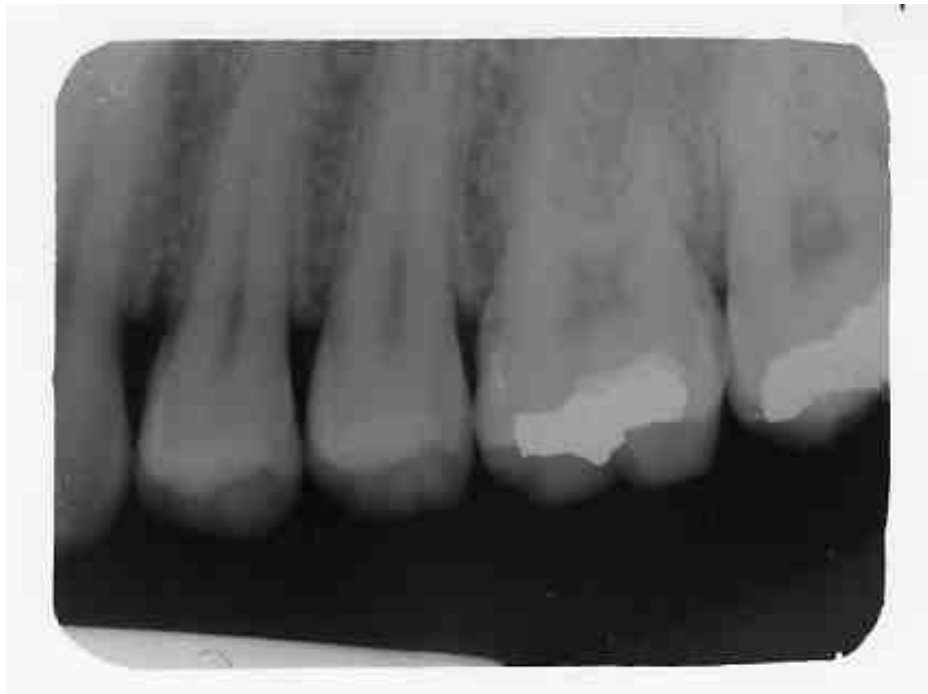
Fig. 8-1

The root apices of the premolars and molars are "cut off" because the film was placed too close to the teeth in the maxillary arch when using the paralleling technique

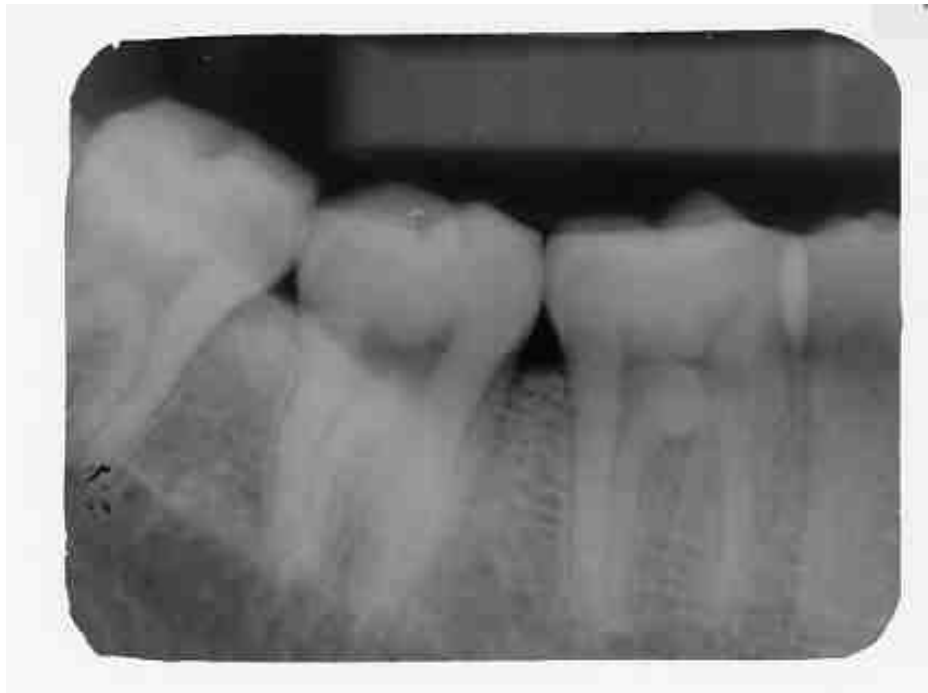
Fig. 8-2

Radiograph of the mandibular molar region does not show all of the specific region on the film. The third molar has been "cut off". The film needs to be placed farther posteriorly

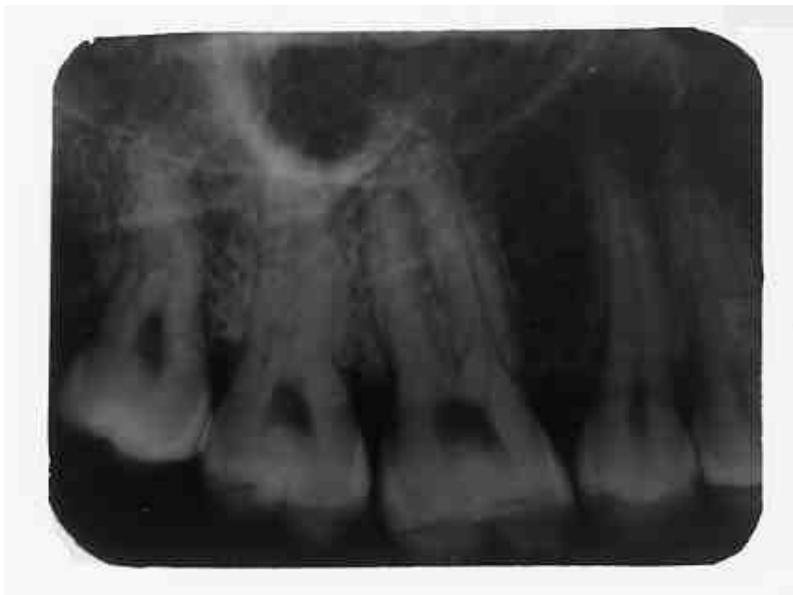
Fig. 8-3

High film density. The dark radiograph is due to an error either in exposure factors or in processing factors or in patient characteristics. (1) Exposure errors include high mA, high kVp, high exposure time, or short source-film distance. (2) Processing errors include fogged film; high developing temperature; films left in developer for longer than usual time; depleted, contaminated or exhausted solutions. (3) Patient characteristics include x-raying edentulous, pediatric, or small face patients without a corresponding reduction in any one of the exposure factors (mA, kVp

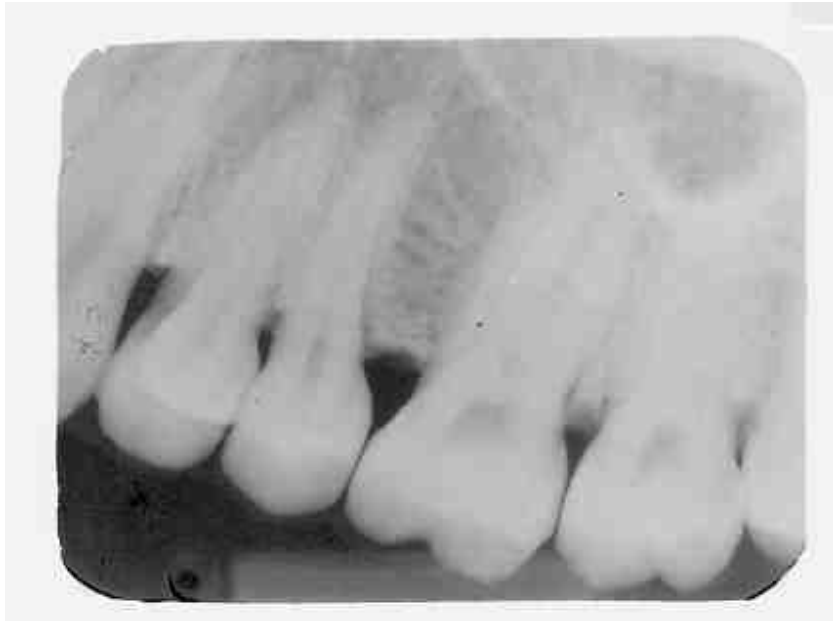
Fig. 8-4

Low film density. The light radiograph is due to an error either in exposure factors or in processing factors or in patient characteristics. (1) Exposure errors include low mA, low kVp, low exposure time, or long source-film distance. (2) Processing errors include low developing temperature, films left in developer for shorter than usual time, dilute solutions, or films left in fixer for an extended period of time. (3) Patient characteristics include x-raying big face or dense bone patients without a corresponding increase in any one of the exposure factors (mA, kVp, or time). (Low film density due to herringbone, tire-track, or honeycomb effect is discussed separately because of its characteristic radiographic appearance).

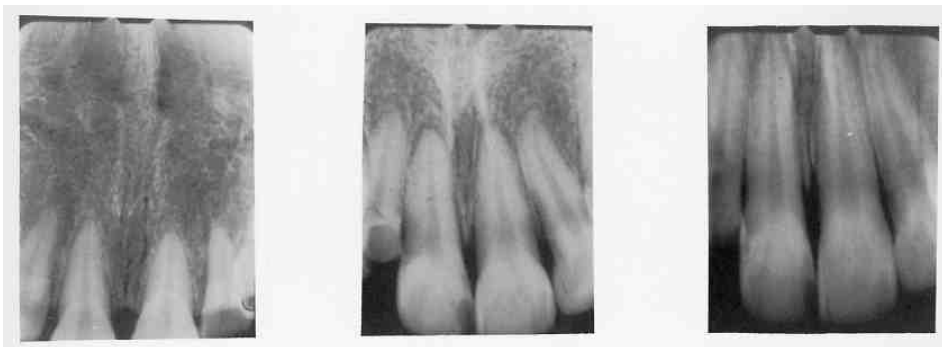
Fig. 8-5

Incorrect vertical angulation produces shape distortion in bisecting the angle technique: (left) foreshortening due to overangulation, that is, increased vertical angulation of cone (PID) in relation to the occlusal plane; (center) correct length of teeth without any distortion; (right) elongation due to underangulation, that is, decreased vertical angulation in relation to the occlusal plane.

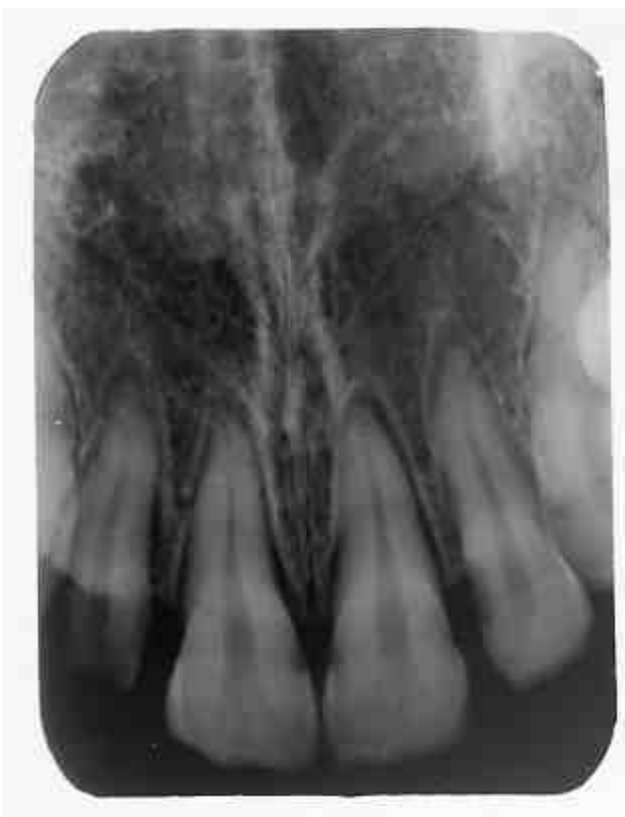
Fig. 8-6

Foreshortening of maxillary teeth due to increased positive vertical angulation (overangulation) of cone (PID) in bisecting the angle technique. For mandibular teeth, foreshortening would be due to increased negative vertical angulation in relation to the occlusal plane.

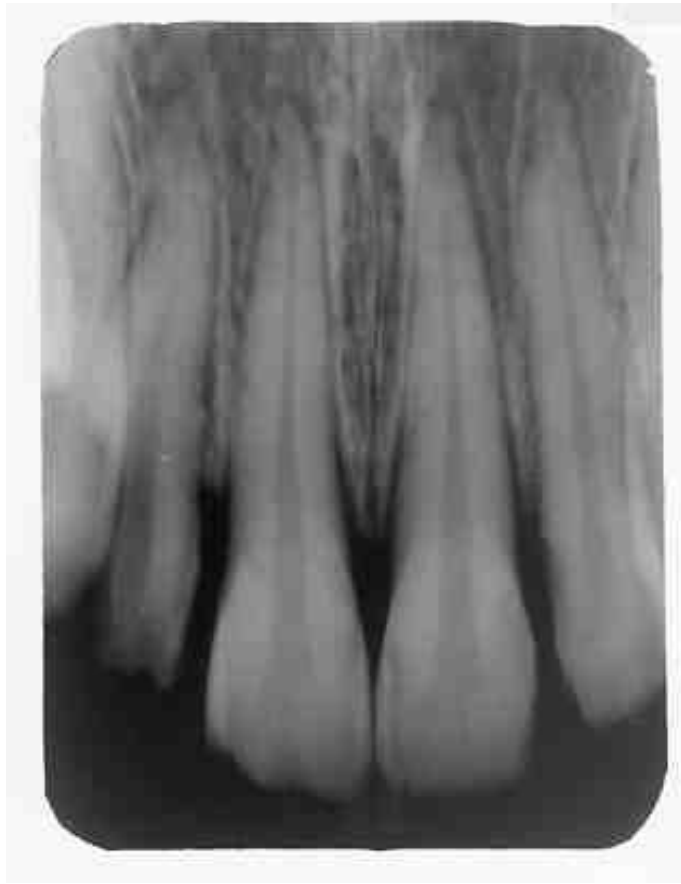
Fig. 8-7

Elongation of maxillary teeth due to decreased positive vertical angulation (under-angulation) of cone (PID) in bisecting the angle technique. For mandibular teeth, elongation would be due to decreased negative vertical angulation in relation to the occlusal plane.

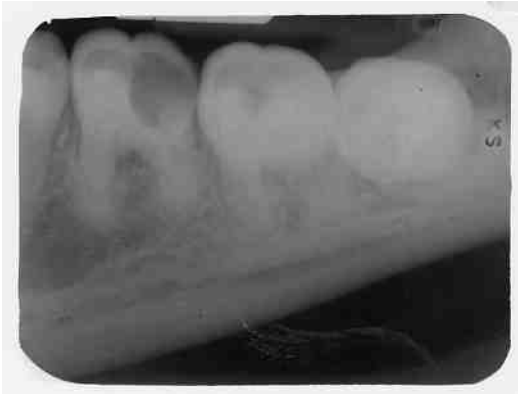
Fig. A

Effect of changes in vertical angulation on mandibular teeth.

Foreshortening of posterior mandibular teeth due to increased negative vertical angulation. The lower border of the mandible is visible due to foreshortening.

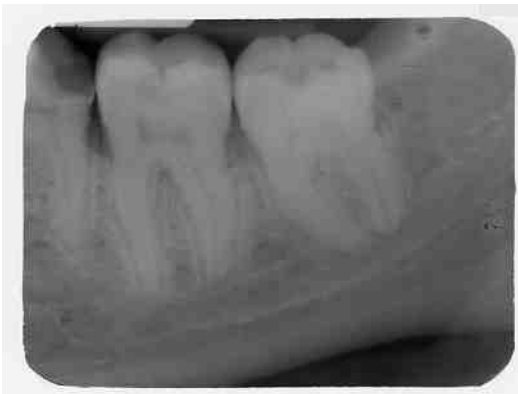
Fig. B

Correct length of posterior mandibular teeth.

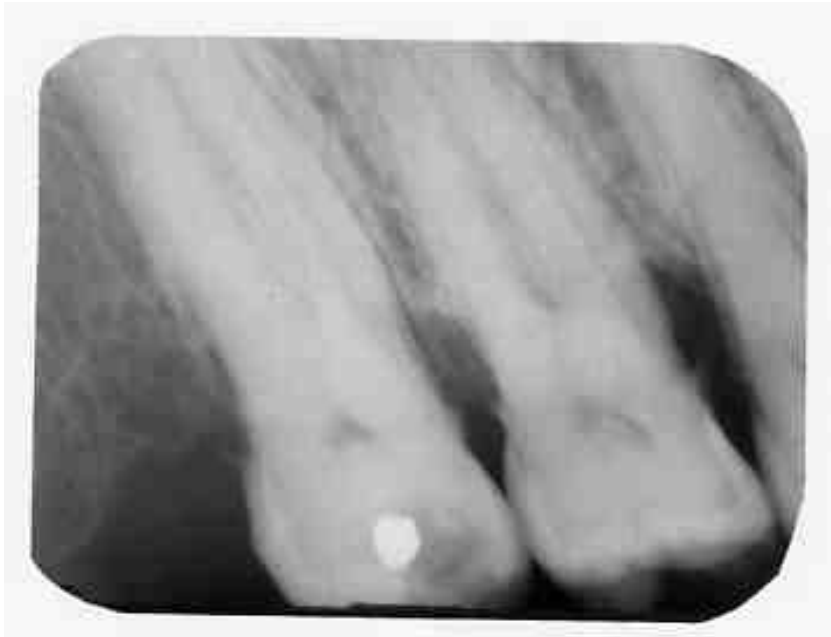
Fig. 8-9

Elongation of posterior teeth due to underangulation of x-ray cone in bisecting the angle technique. The apices of teeth are not visible because of the severity of shape distortion.

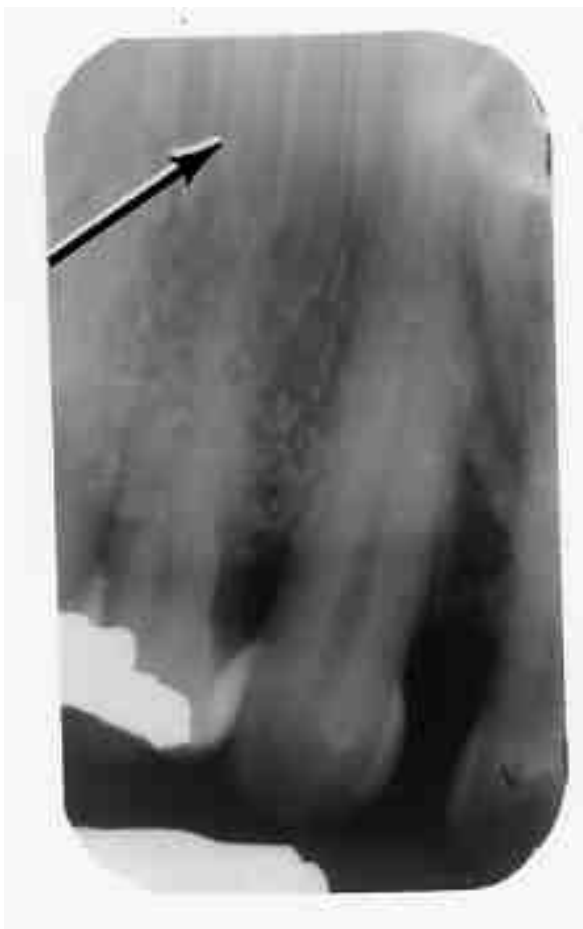
Fig. 8-10

Film curving. Shape distortion due to the curving of the film at time of exposure. The superior end of the film was inadvertently curved during patient x radiation. Notice the stretched-out (elongated) bone trabeculae superior to the root apices of the maxillary teeth.

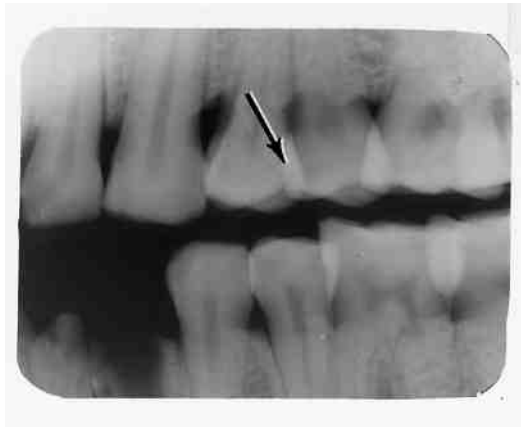
Fig. A

Changes in horizontal angulation.

Incorrect horizontal angulation results in overlapping of contact points of premolars.

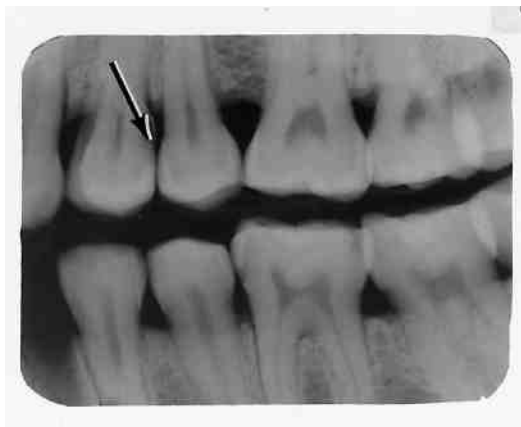
Fig. B

Correct horizontal angulation results in visible contact points of premolars.

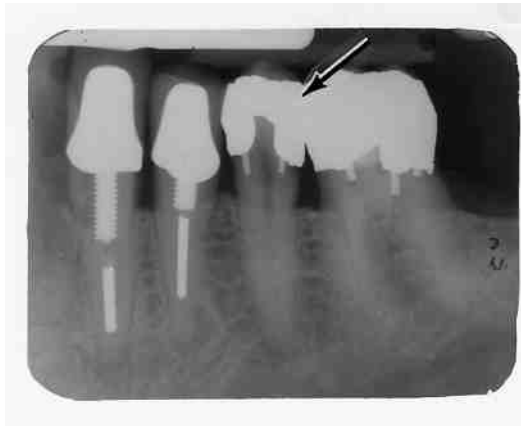
Fig. A

Illusion produced by changes in horizontal angulation.

Illusion of a closed contact point between the second premolar and first molar due to incorrect horizontal angulation.

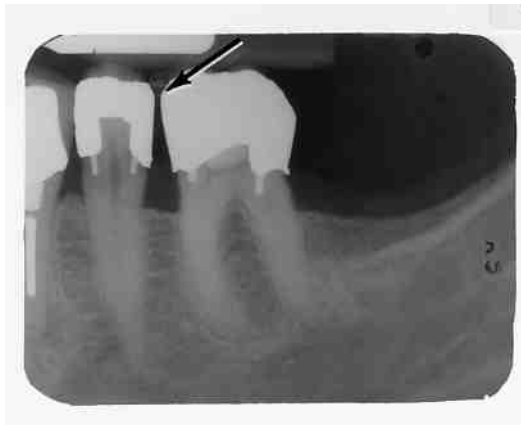
Fig. B

Open contact point visible when correct horizontal angulation is used.

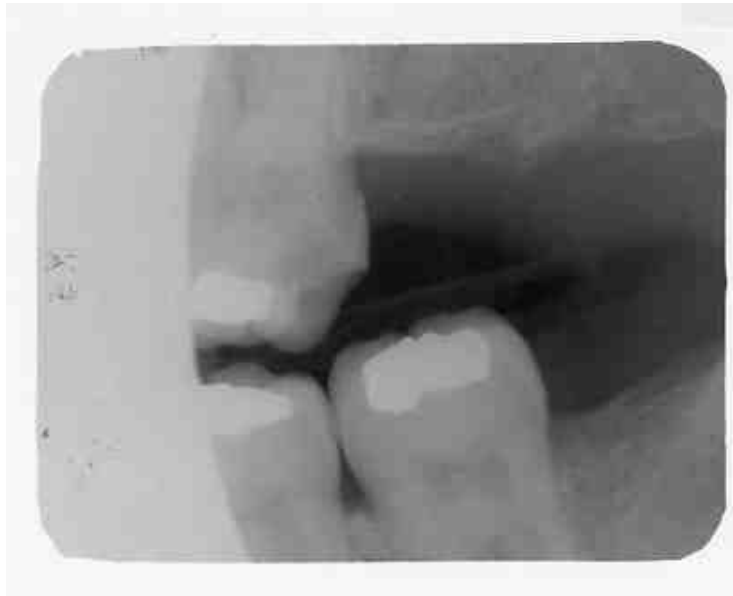
Fig. 8-13

Cone-cut caused by improper alignment of circular cone (PID) with film packet. The cone of radiation did not cover the whole area of interest. The clear portion of the film was not exposed to x rays.

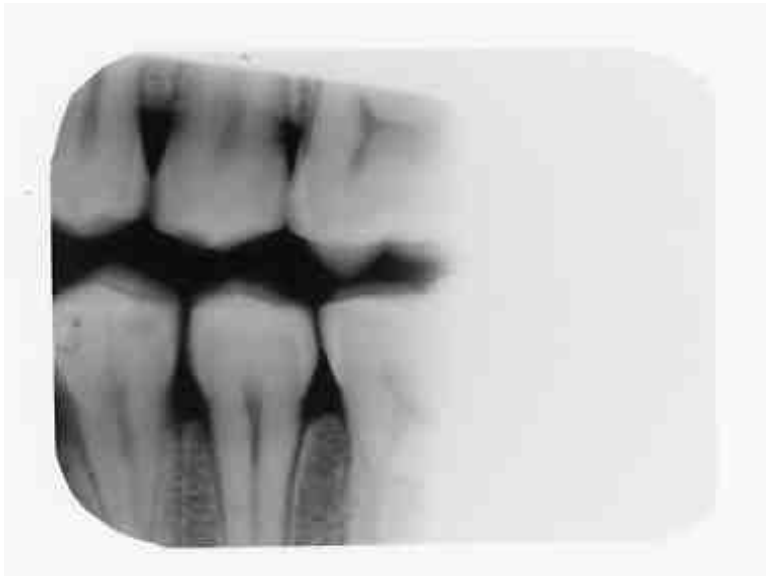
Fig. 8-14

Cone-cut caused by improper alignment of rectangular cone (PID) with film packet. The clear portion of the film was not exposed to x rays.

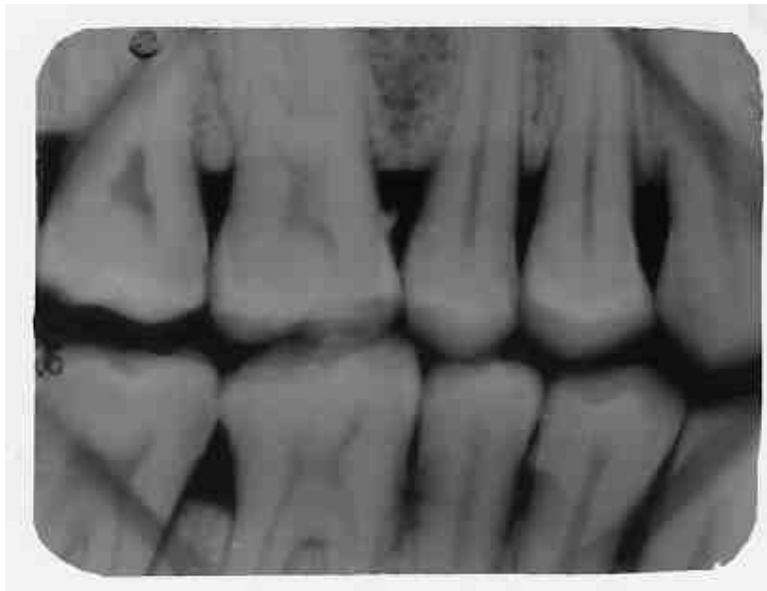
Fig. 8-15

Bent film. The black lines caused by creasing the film packet at the four corners produced breaks in the emulsion.

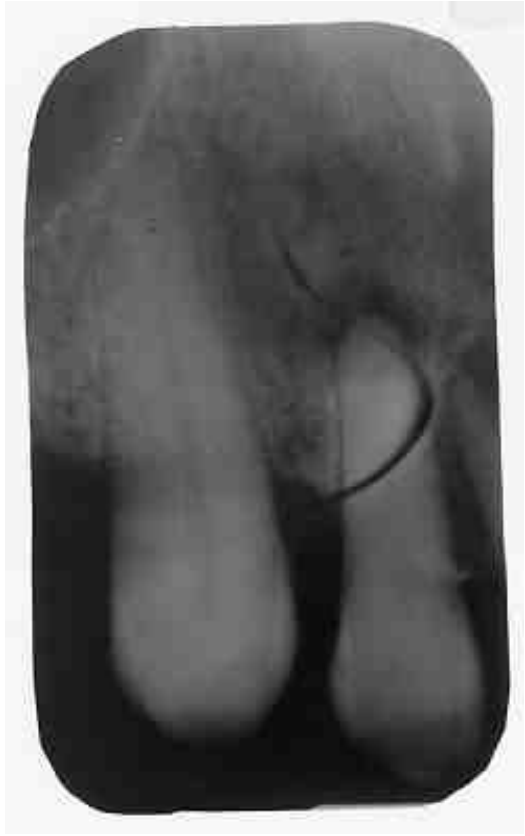
Fig. 8-16

Bent film. Film was accidentally crimped when inserting it into the slot of the bite-block. Similar small crescent shaped images have been erroneously interpreted by many authors as fingernail pressure marks. Clinically, it is difficult to produce fingernail pressure marks on a film.

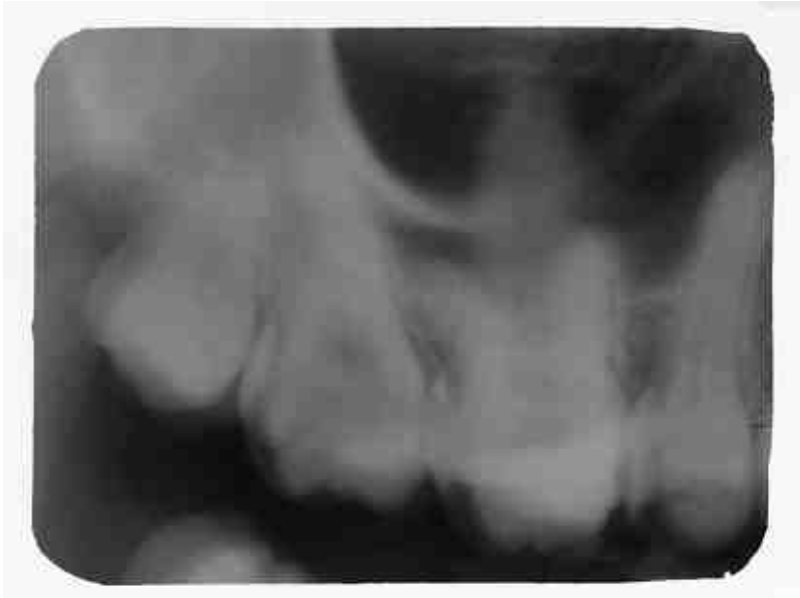
Fig. 8-17

Blurred image due to movement of the film, patient, or tubehead.

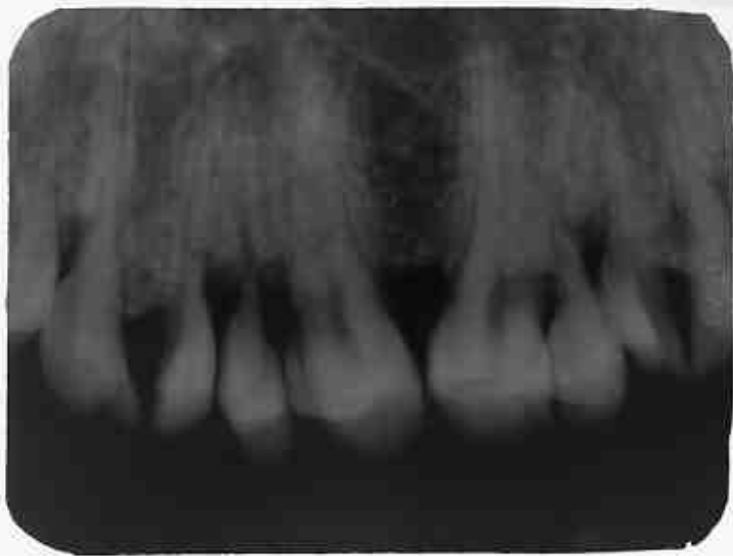
Fig. 8-18

Double exposure.
The film was exposed
twice, resulting in a
double image.

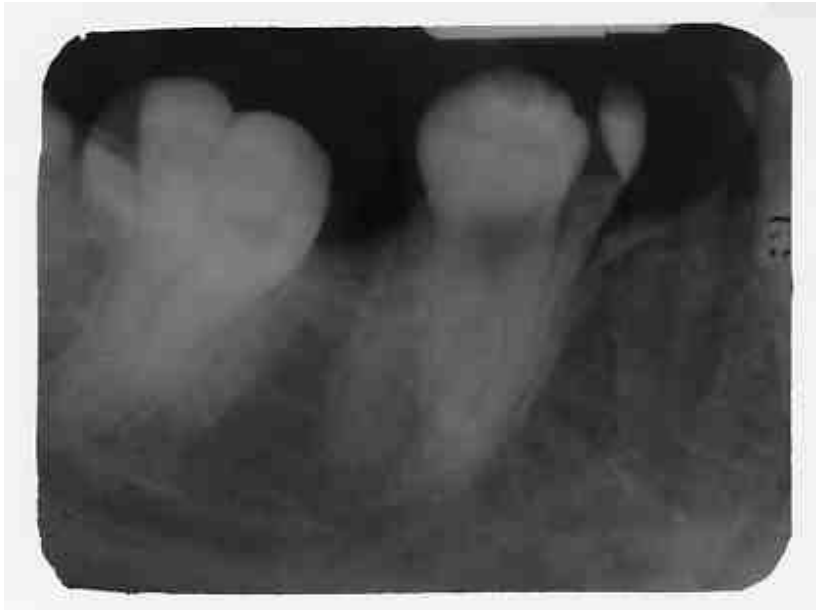
Fig. 8-19

Double exposure.
The film was exposed
twice, resulting in a
double image.

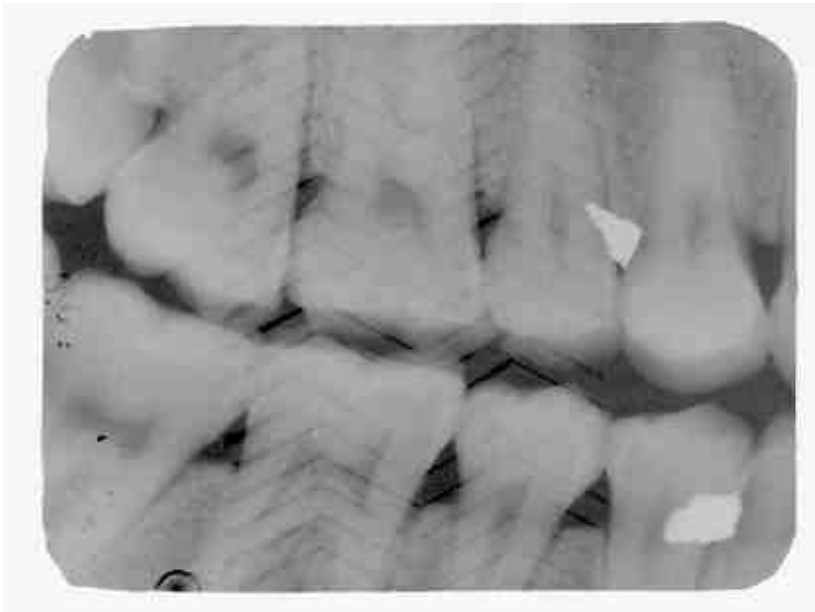
Fig. 8-20

Herringbone effect. The film was exposed from the nonexposure surface, that is, the printed back side of film faced the x-ray beam. The film is of low density (light) because the lead film-backing absorbed most of the x rays. Sometimes a honeycomb or tire-track effect may be seen.

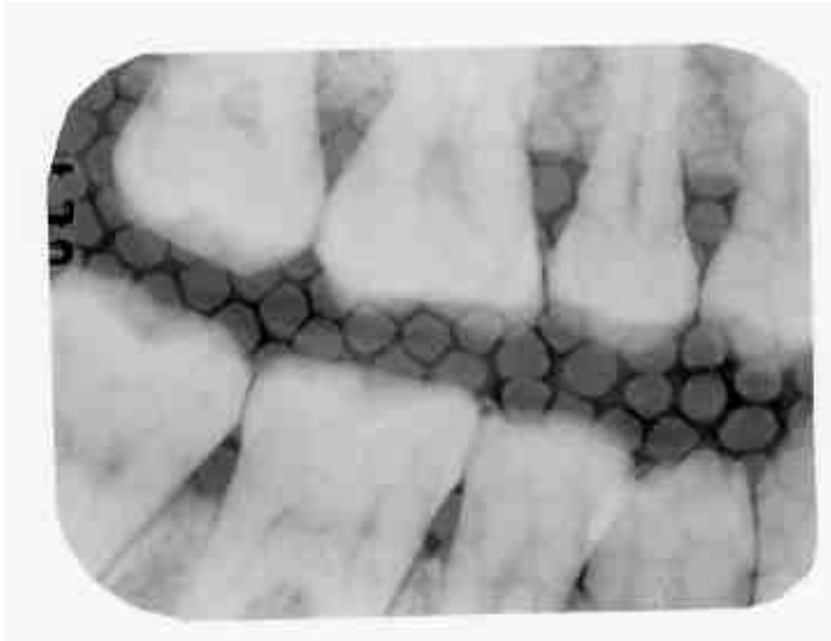
Fig. 8-21

Honeycomb effect. Cause is similar to that of the herringbone (or tire-track) effect. The film was exposed from the nonexposure surface. The film is of low density because the lead film-backing absorbed most of the x rays.

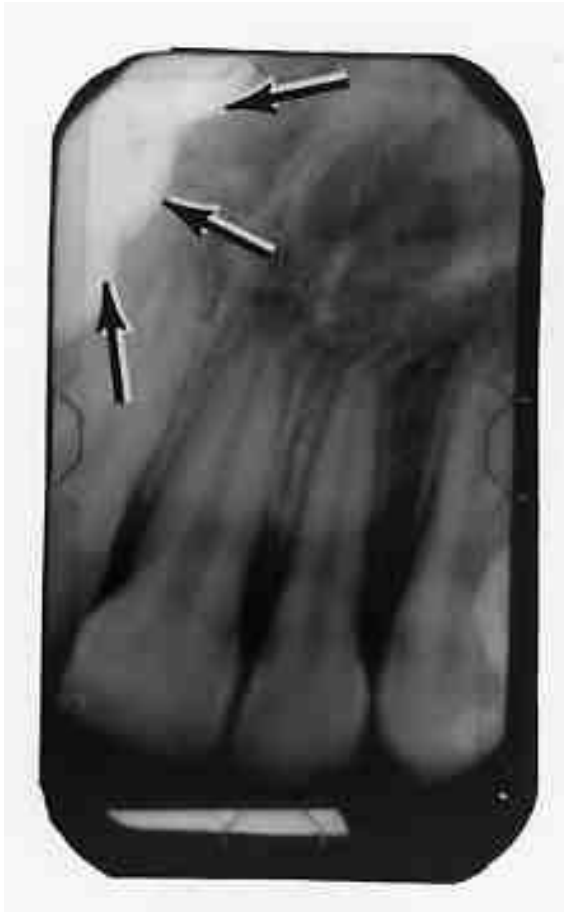
Fig. 8-22

The radiopaque images (arrows) are those of the maxillary posterior teeth of contralateral side. During exposure, the upper mesial corner of the film was erroneously placed occlusally to the contralateral maxillary posterior teeth.

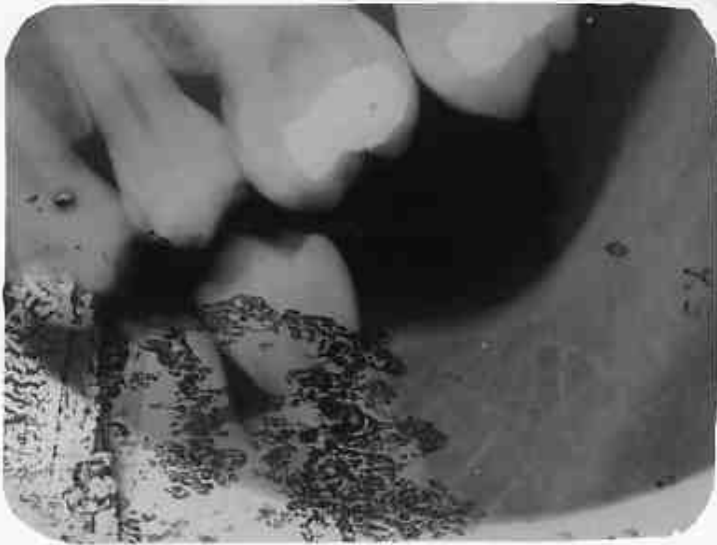
Fig. 8-24

The film packet was handled in the darkroom with fingers (gloves) contaminated with saliva. The black mark (X) is the moist black paper stuck to the film. The white clear mark (Y) is the emulsion torn away from the film.

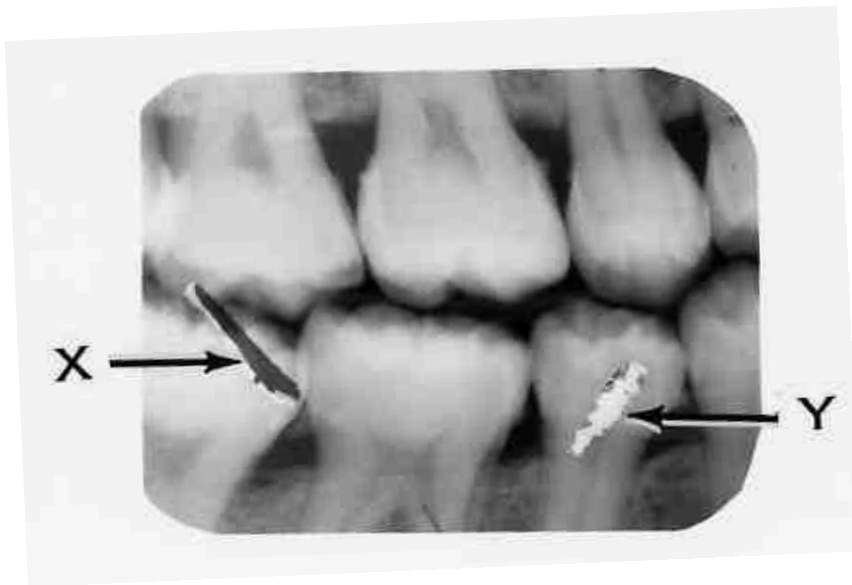
Fig. 8-25

Two films stuck
together in the
automatic processor.

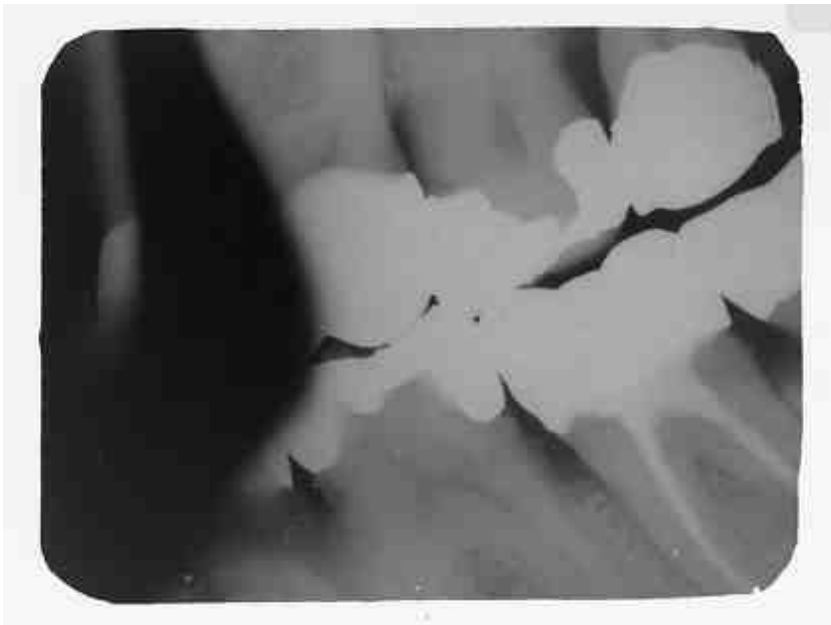
Fig. 8-28

Part of the film packet was accidentally opened in daylight and, therefore, became black.

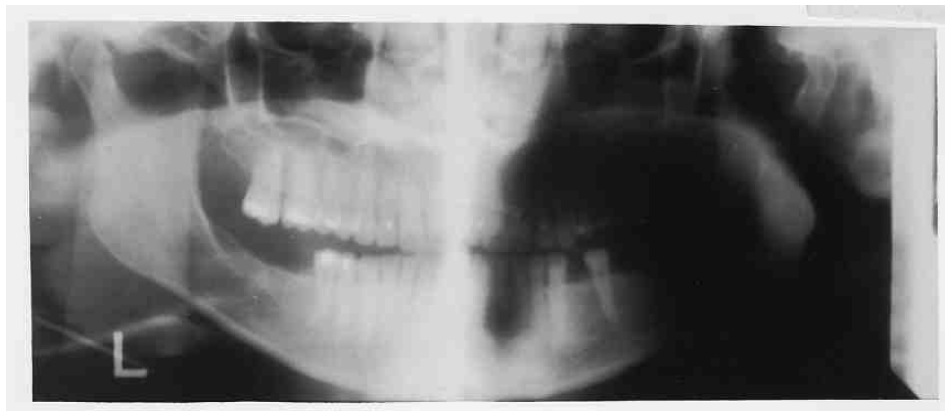
Fig. 8-29

Part of the film was exposed to light through a faulty cassette joint and, therefore, turned black.

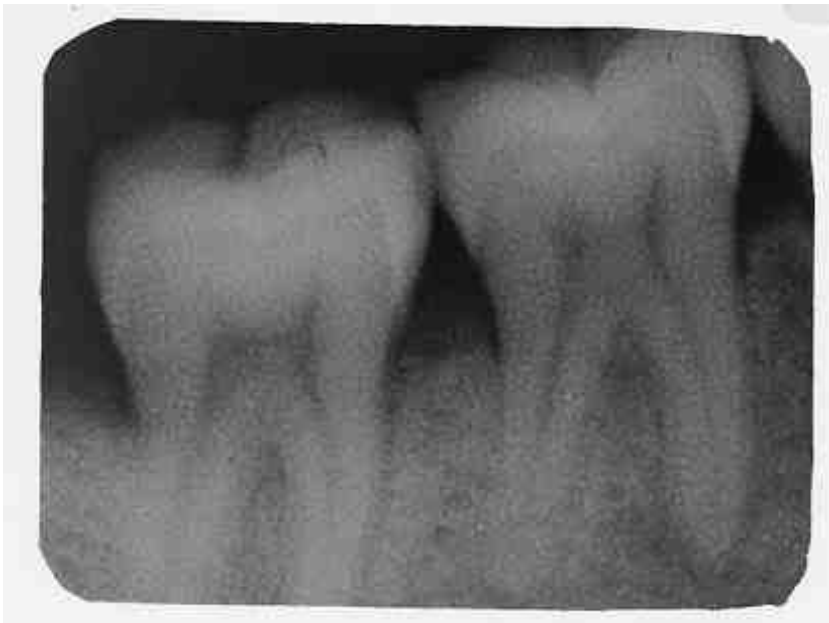
Fig. 8-30

Reticulation (orange peel appearance) is caused by sudden extreme temperature changes in manual processing. For example, the developer temperature could be very high and the rinse water temperature could be very cold, the alternate swelling and shrinking of the film emulsion can cause reticulation. This artifact occurs mainly in manual processing; it has not been observed in automatic processing.

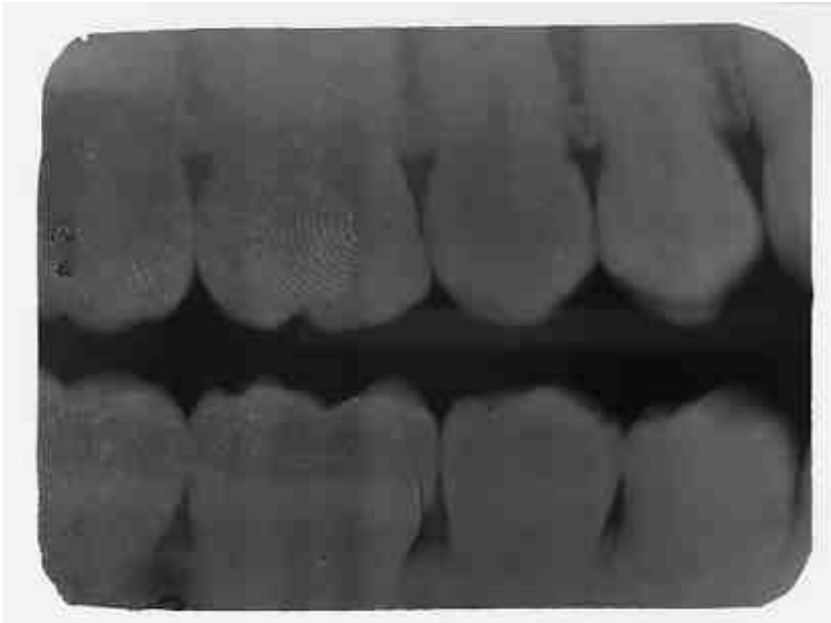
Fig. 8-31

Yellow or brown stains on film caused either by using exhausted or depleted processing solutions, or by insufficient washing of film. Operator's finger prints are also visible on this radiograph.

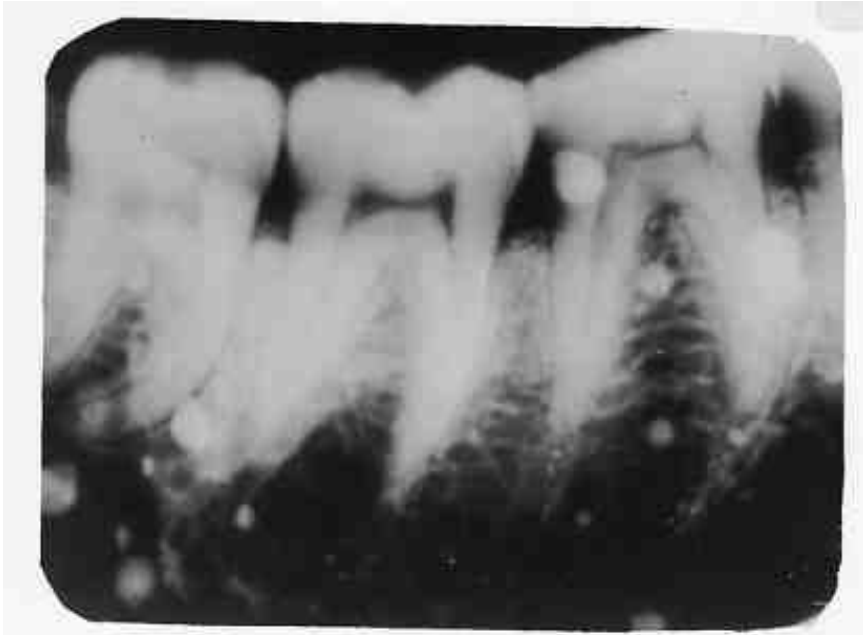
Fig. 8-32

Air bubbles clinging on film surfaces during manual processing prevent developer from reducing the emulsion beneath them. These air bubbles cause white spots on the film.

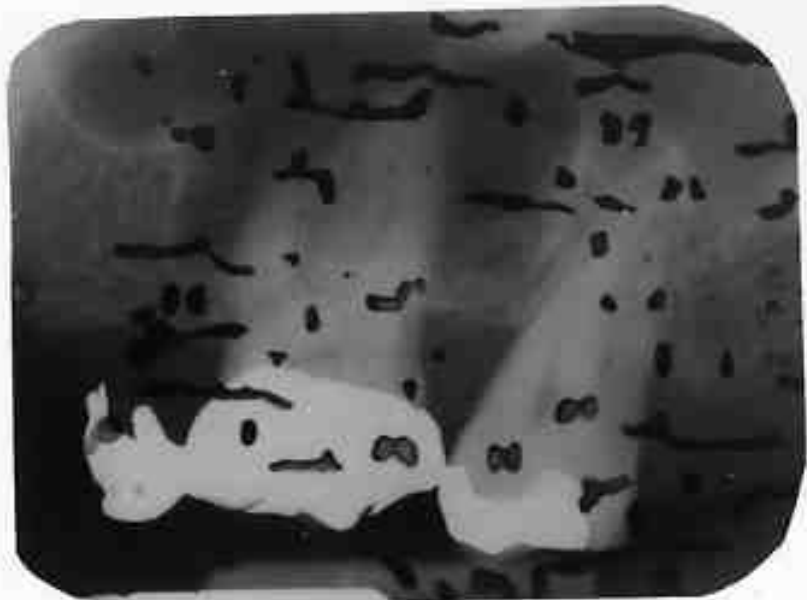
Fig. 8-33

Developer artifact.
Developer solution
splashed on the table-
top. Unwrapped films
were placed on the
chemically
contaminated table-
top before being
processed in the
automatic processor.

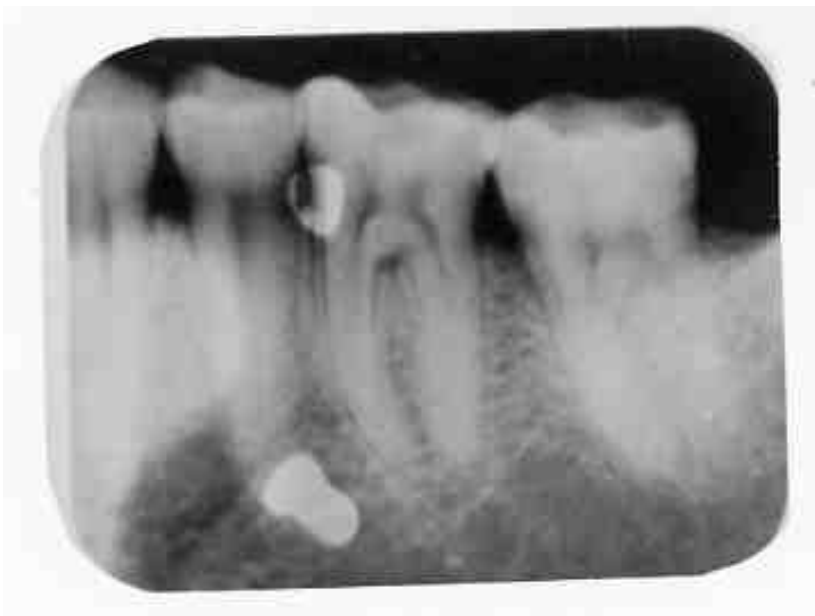
Fig. 8-34

Fixer artifact. Fixer solution accidentally splashed on the film before processing. The fixer cleared the undeveloped silver bromide crystals of the film emulsion.
(Courtesy, Eastman Kodak Co).

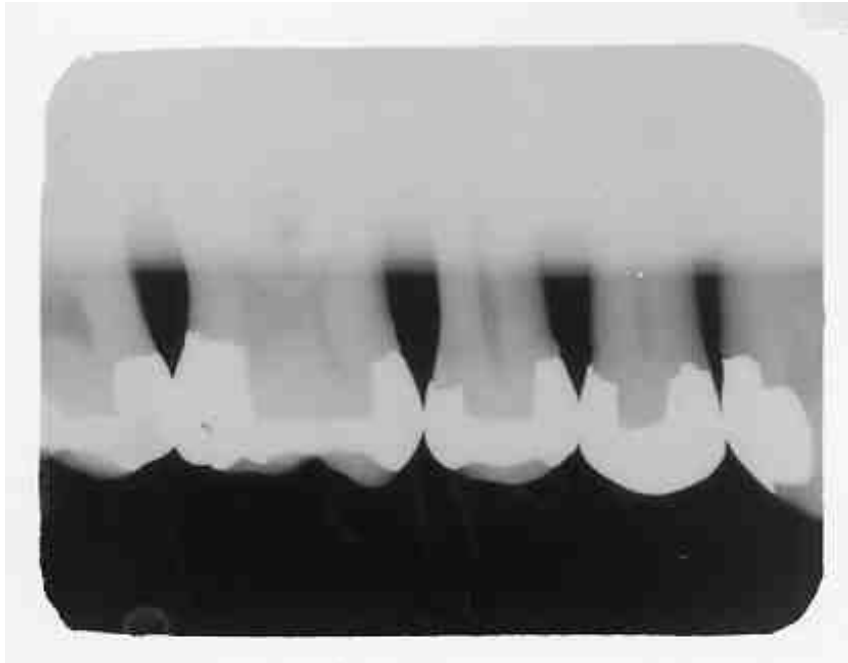
Fig. 8-35

In manual processing, the bottom portion of the film was immersed in the developer and then the complete film was immersed in the fixer. This same effect occurs if the level of the developer in the tank is low.

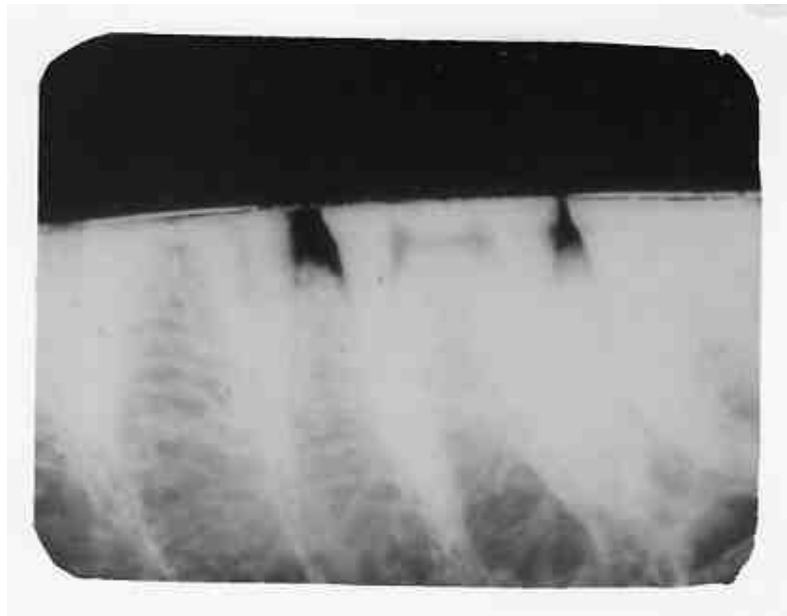
Fig. 8-36

In manual processing, if the top portion of the film is green, it means that only the bottom portion of the film was immersed in the developer and in the fixer.

If the top portion of the film is black, it means that the whole film was immersed in the developer but only the bottom portion was immersed in the fixer.

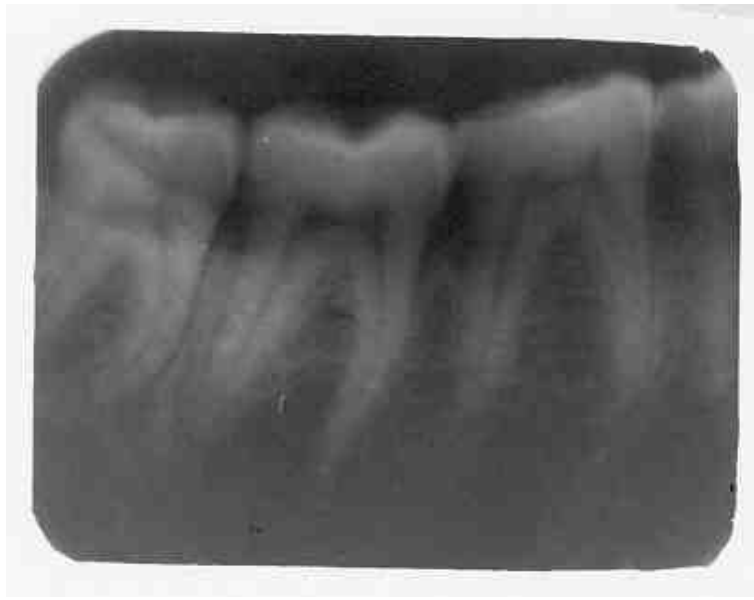
Fig. 8-37

Fogged film. The causes of film fog are:

1. Films used beyond the expiration date
2. Films stored at high temperature or high humidity
3. Films inadequately protected from scattered x-rays
4. Films processed at excessive time and/or temperature
5. Contaminated or exhausted solutions
6. Darkroom safelight too bright (high bulb wattage)
7. Wrong type of filter in safelight or cracked filter
8. Too long exposure to safelight
9. Light leaks in darkroom

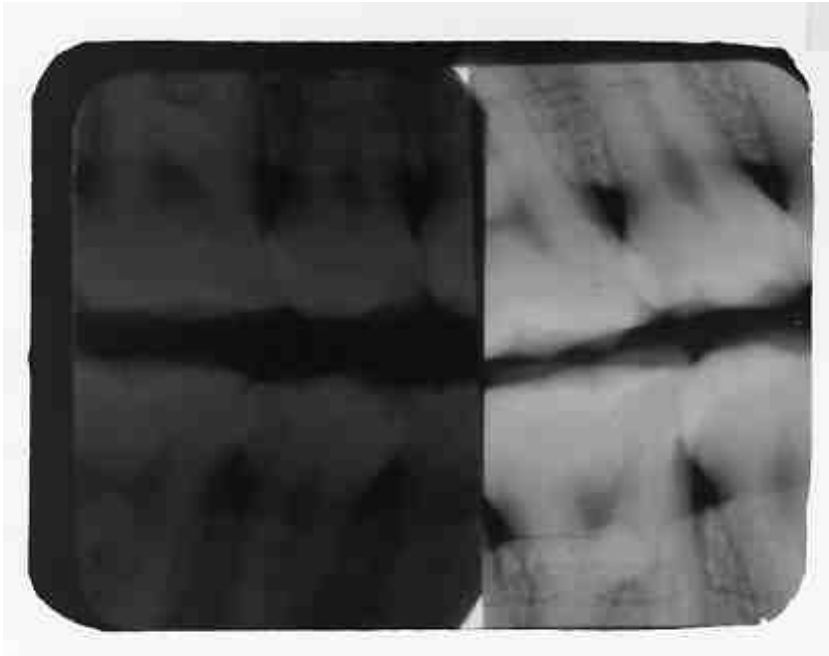
Fig. 8-38

Comparison of fogged
and unfogged films.

(Left) Fogged film;

(Right) Unfogged film.

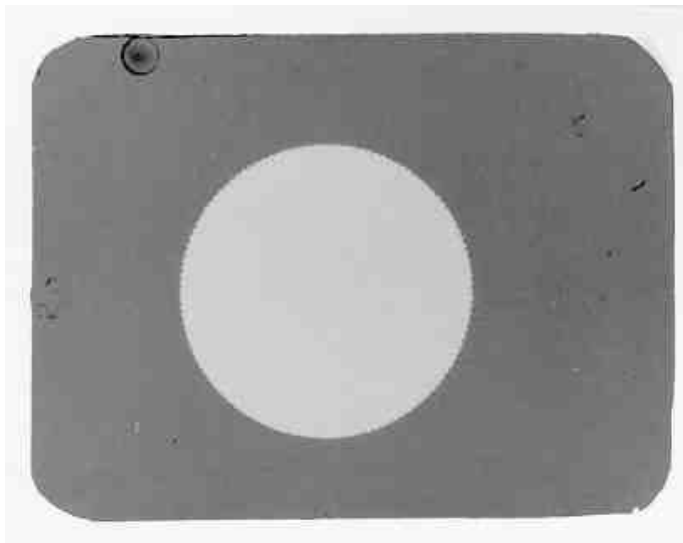
Fig. 8-39

Coin test to determine darkroom light safety. In the darkroom, a coin was placed on an unexposed, unwrapped film and left for about two minutes before processing the film. Since the image of the coin is made visible by the surrounding fogged area, the darkroom is not light safe and should be checked for, 1) possible light leaks into the darkroom, 2) high wattage of light bulb in safelight, 3) wrong filter in safelight, 4) too short a distance between safelight and workbench, 5) cracked filter in safelight.

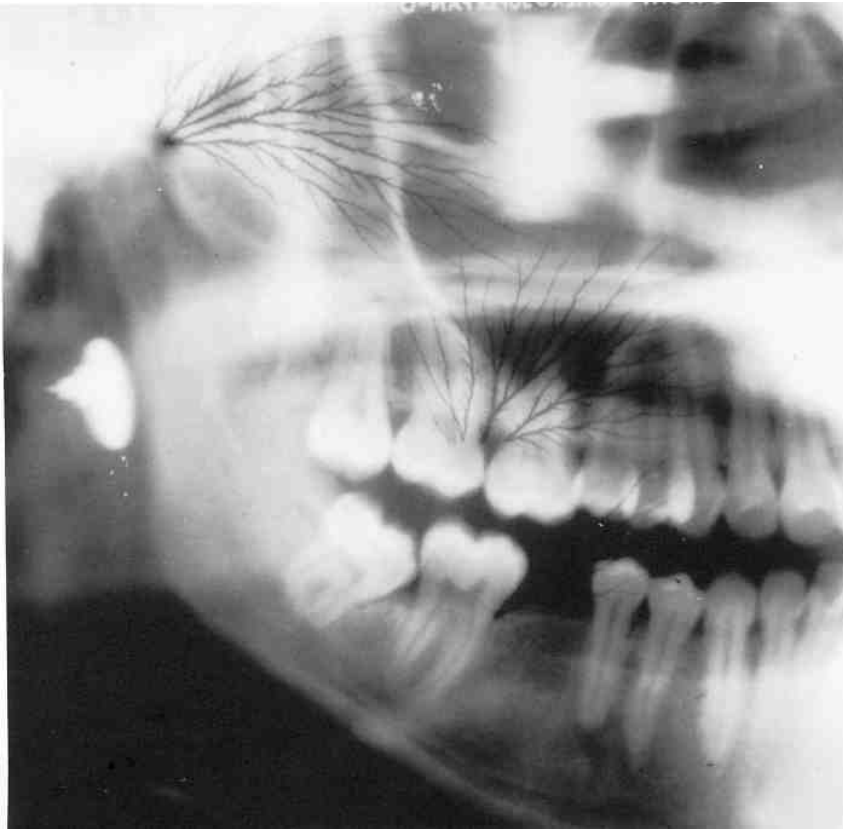
Fig. 8-40

Tree-like dark markings produced by a small charge of static electricity as shown on half a panoramic radiograph. Low humidity and dry film are contributing factors. Static electricity is generated by friction from rapid removal of film from its wrapper or from sliding film on the intensifying screen into the cassette.

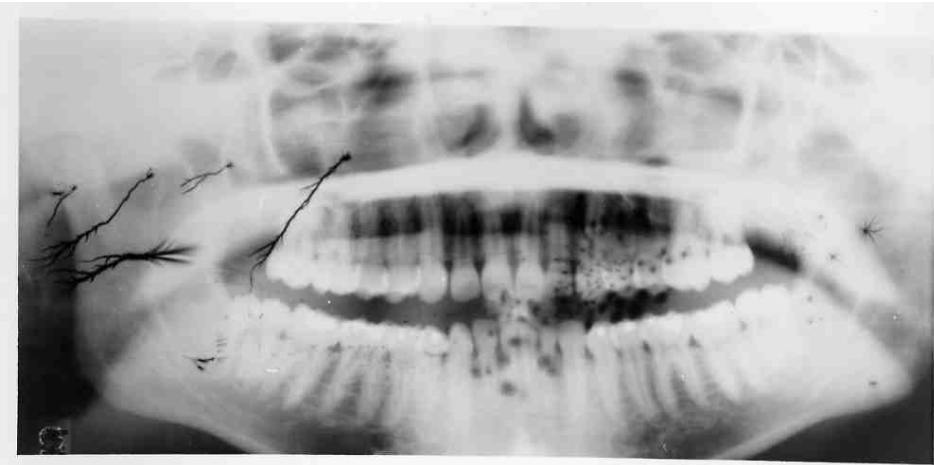
Fig. 8-41

Two types of static electricity markings: (1) The smudge or star-like markings (on anterior teeth and left premolars), and (2) Tree-like markings (on right ramus). Although film friction is the most common cause for static electricity markings, sometimes protective latex gloves may be a source of static electricity and produce a black, smudge-like image on a radiograph.

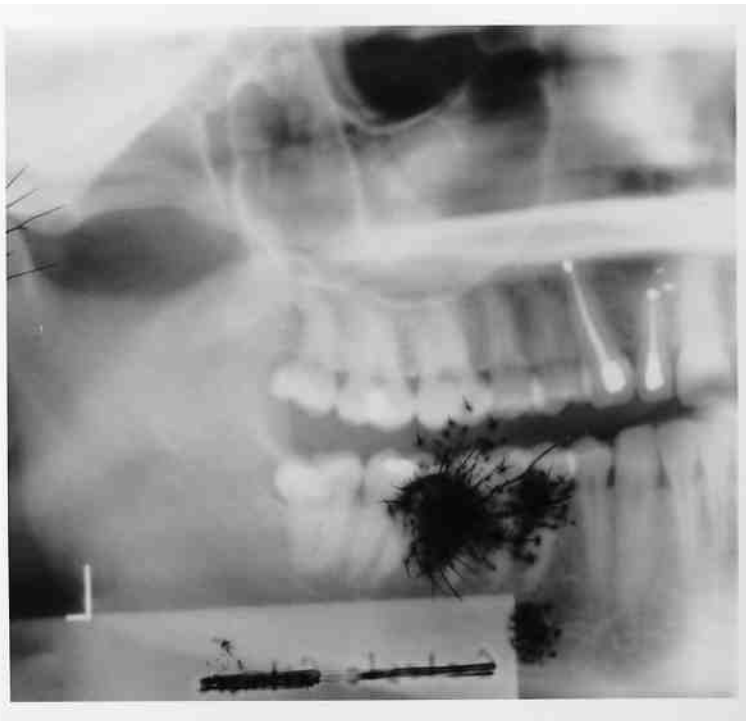
Fig. 8-42

Smudge or star-like
static electricity
markings.
